Valve Lifter/Push Rod Pre-Load Testing

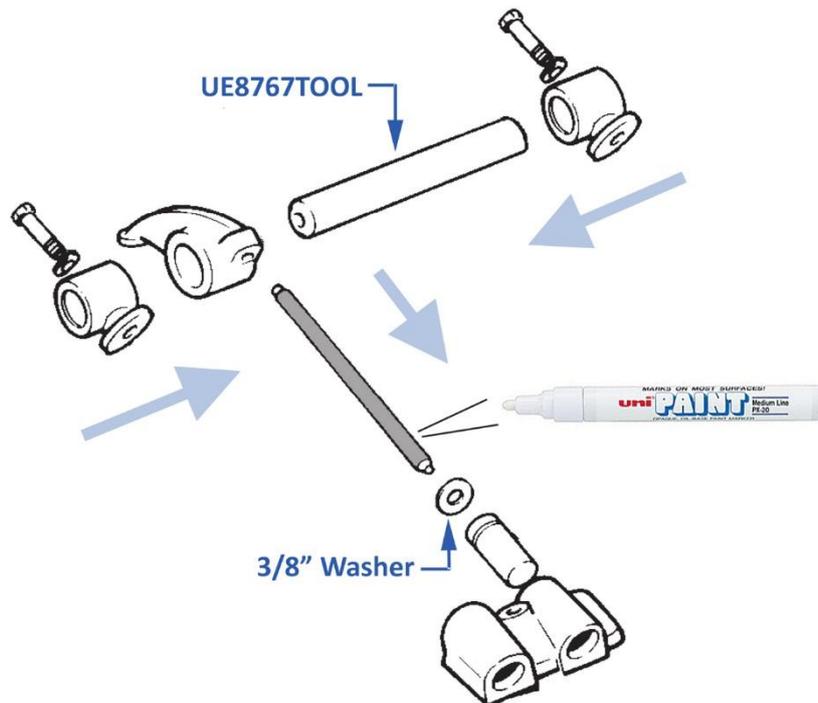
- 6) Mark the push rod with the white paint pen where the top of the washer and the push rod align. Make the marking wide enough so that you can scribe two lines in the white paint (say 6-8mm or 1/4-3/8”).

- 7) Tighten the rocker pedestal screws down to the correct setting (8-10 lb/ft or 1.1-1.4 kg/m).

- 8) Scribe a first line in the white paint, where the top of the washer aligns with the push rod.
